# A Non-Destructive Technique for Health Assessment of Fire-Damaged Concrete Elements Using Terrestrial Laser Scanning

Wallace Mukupa\*, Gethin W. Roberts, Craig M. Hancock, Khalil Al-Manasir  
Department of Civil Engineering, The University of Nottingham Ningbo, China  
199 Taikang East Road, University Park, Ningbo 315100, China.

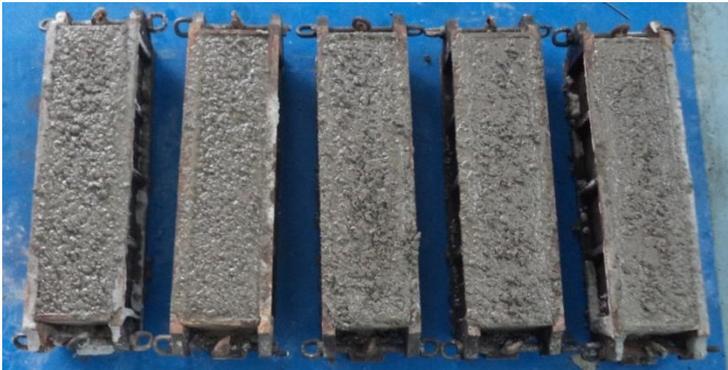
Fig. 1: Concrete specimens cast in steel moulds

The concrete specimens were cast in steel moulds (Fig. 1) and consolidated using a high frequency vibrating table. After 24 hours of casting, the specimens were removed from the moulds and then cured in a fresh water tank where the temperature and humidity were kept at 20±2°C and 40% respectively for 28 days.

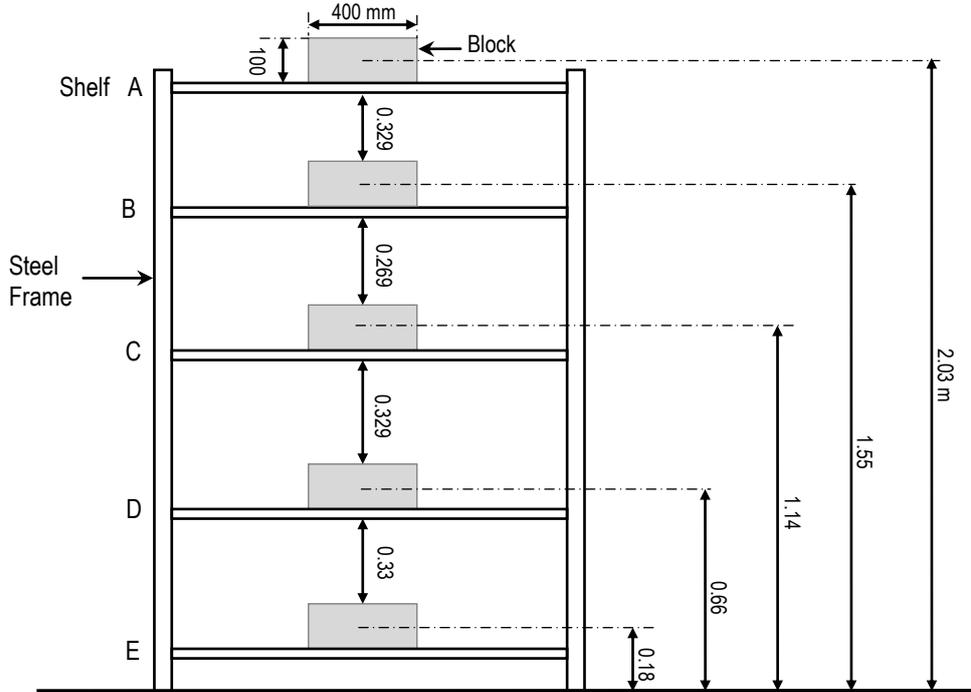
Fig. 2: Steel Frame and Blocks at Different Levels. The letters A, B, C, D and E stand for shelves.

The planned distances for investigation between the scanner and concrete blocks were 1, 2, 3, 4, 5 and 6 metres and the total station (TS 11) was used in the measurement setup and in particular marking out the scanning distances. The geometry of the experiment in terms of scanning measurement setup is shown in Fig. 2.

With reference to Fig. 2, the planar surface of each concrete block was properly aligned with the frame edge. The concrete blocks were placed at different heights on shelves of the steel

frame with the control block on the centre shelf at the same height as the scanner with its front face approximately vertical and perpendicular to ensure that scanning was done at roughly normal angle of incidence. The experiment was set-up this way in order to only focus on the scanning geometry as the factor influencing the poor laser returned signal. The scanning parameters used in the experiments are shown in Table 4 and involved a comparative analysis of scanning resolutions for the two scanners used as compiled from the user manuals courtesy of Leica Geosystems and FARO Technologies.

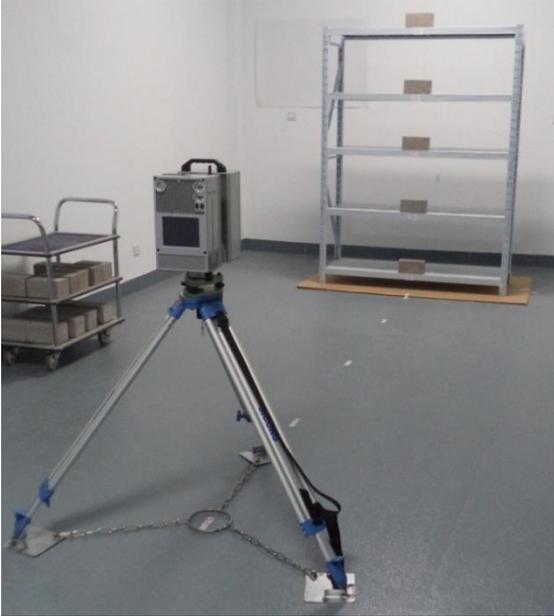
Fig. 3a: Scanning using the HDS7000 scanner

Fig. 3a and 3b below show the experiment setup when the HDS7000 and the FARO scanners were used to scan the concrete specimens. The whole essence of using two types of scanners was to investigate the behaviour of two different scanners and investigate their relationships since the two scanners that were used have different wavelengths for instance.

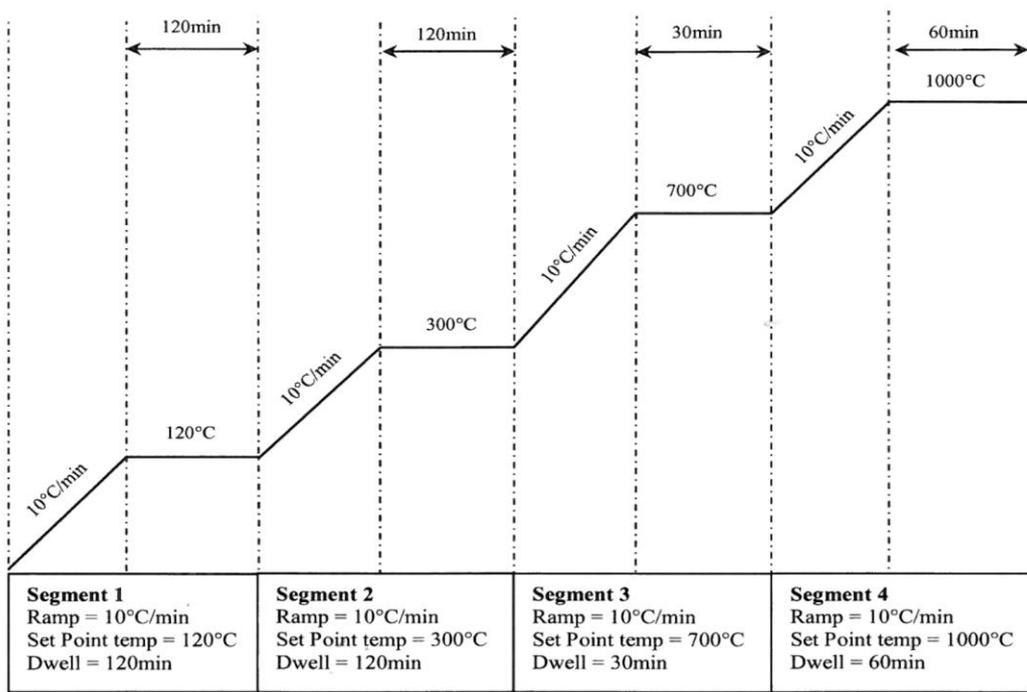
Fig. 4: Thermal cycle for the concrete block heated to 1000°C

After scanning the unheated concrete specimens with the two laser scanners, the specimens had to then be heated. A Carbolite CWF 12/23 electric furnace was used for the thermal treatment of the specimens. The specimens at an age of 98 days were placed in the furnace chamber and thereafter heated at designated temperatures of 250, 400, 700, and 1000°C with a ramping rate of 10°C/min. For each heated specimen, thermal cycles were followed as depicted in (Fig. 4) for the specimen that was heated to 1000°C because rapid heating rate can also result in higher vapour pressure and cause cracks in concrete [4]. The peak temperatures were maintained for 1 hour and then after an exact period of 1 hour, the furnace was switched off with the specimen inside and left to cool down to room temperature in order to avoid thermal shock. For comparison purpose with the other heated specimens, one specimen was left unheated.

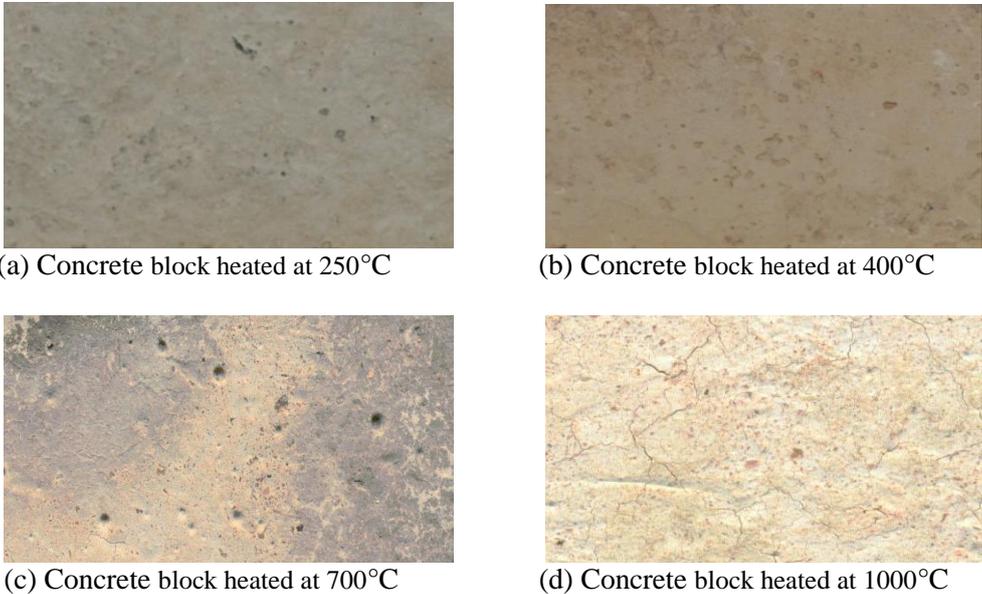
Fig. 5: Colour Change of Heated Concrete.

Visual inspection of colour change is for instance one of the initial steps in assessment of fire-damaged concrete [12] which may then be followed by detailed investigations [9]. Visual inspection of colour change of heated gives an idea of the modification in the properties of concrete [28] and shown in Fig. 5 are the concrete specimens and their respective colour change after heating.

The concrete colour changes in Fig. 5 generally show the same widely reported colours of concrete containing siliceous aggregate when it is heated to high temperatures as mentioned above. Importantly, colour changes as observed in Fig. 5 can be useful in identifying the extents of fire-damaged concrete [5] and it has been widely reported that a significant loss in strength occurs when concrete is heated above 300°C and that normally this coincides with a concrete colour change of red or pink [13] as in Fig. 5 (b). RGB Image analysis of concrete specimens captured by a flatbed scanner was done on small cropped image sections of size 7x7cm in order to reduce computational intensity and Fig. 6 shows the results.

Fig. 6 above shows the intensities of the three primary colours i.e. red, green and blue colours at different designated temperatures for concrete specimens. It can be observed that the red and green colours start at almost around the same point. Throughout the temperature range investigated the red and green colour intensities were higher than the blue colour. However, the blue colour like the green and red colours, showed a significant raise in intensity for the concrete specimen heated to 1000°C. The variations in intensity for the RGB channels in Fig. 6 were explained by the colour changes of the heated concrete (Fig. 5).

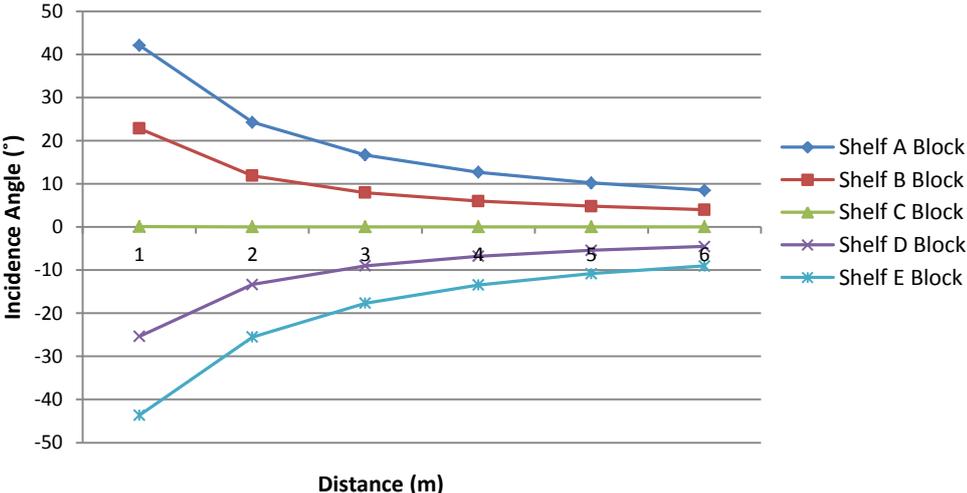
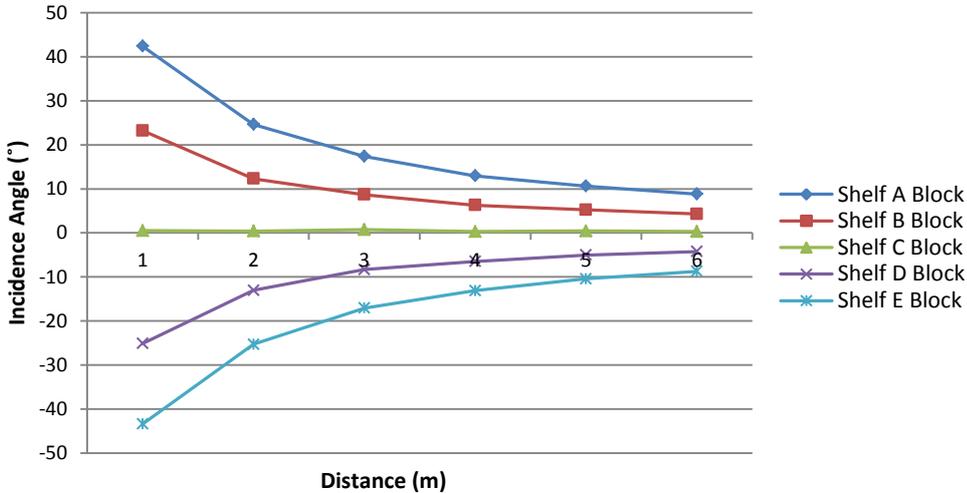
The measurement of the incidence angles for the blocks in the experiments (see measurement setup in section 2.3) varied with distance. As the scanning distance increased, the incidence angle decreased and both scanners used showed the same trend as shown in Fig. 7 and 8 below:

Fig. 7: Incidence Angle against Distance – HDS7000 Scanner

Fig. 8: Incidence Angle against Distance – FARO Scanner

In line with the above findings, Krooks *et al.* [26] also investigated the relation between incidence angle and distance (range) and it has been reported that in several fieldwork applications of static TLS where a survey is conducted with the scanner mounted on the tripod, changes in the angle of incidence occur as the measurement range increases.

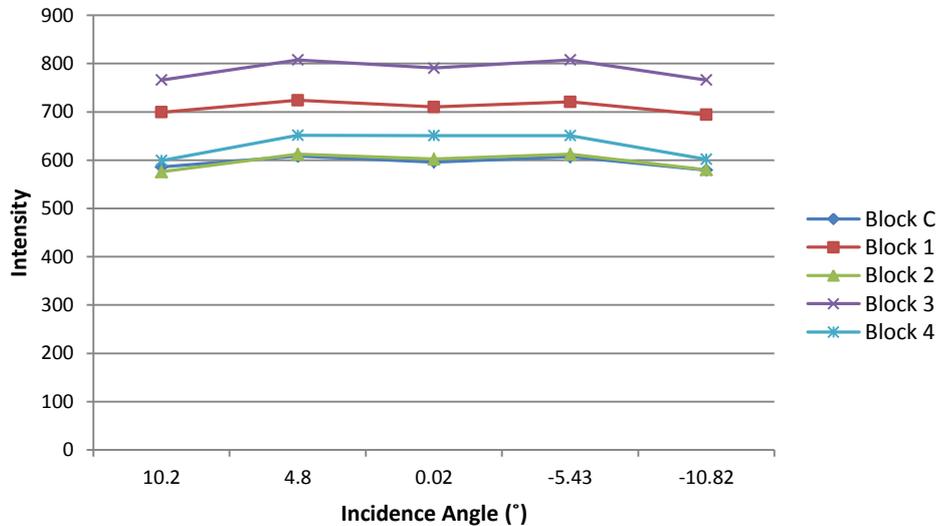
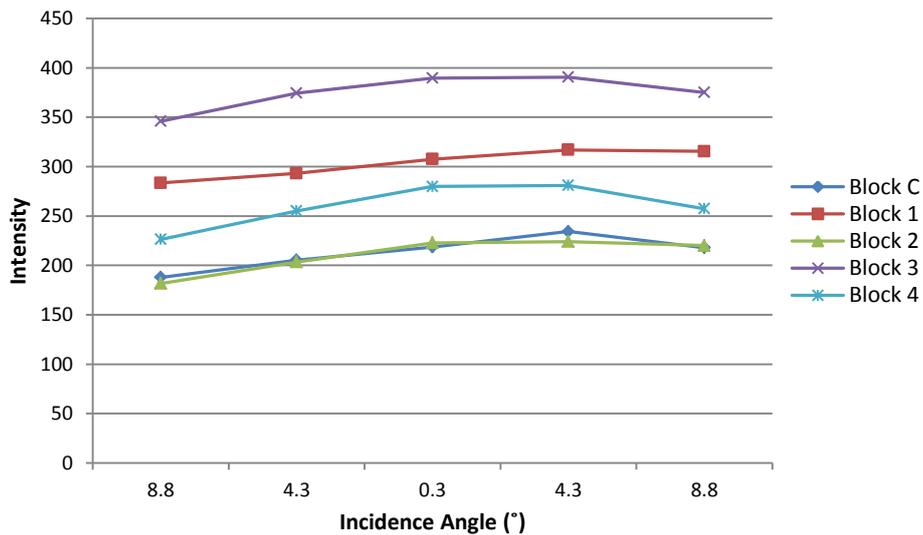
In theory, the closer the laser beam incidence angle is to  $0^\circ$  the more the returned intensity. It has been reported that higher incidence angles of for instance  $20^\circ$  and more lead to diminished returned intensity [26]. The results presented below are for blocks that were scanned at incidence angles less than  $12^\circ$  and with the scanning distance held fixed. Fig. 9 and 10 show the relationship between intensity and incidence angle and it can be seen that the effect of the incidence angle on the intensity is insignificant as the graphs for all the blocks tend to straighten across the whole range of the incidence angles.

Fig. 9: Intensity against Incidence Angle at 5m – HDS7000

Fig. 10: Intensity against Incidence Angle at 6m - FARO

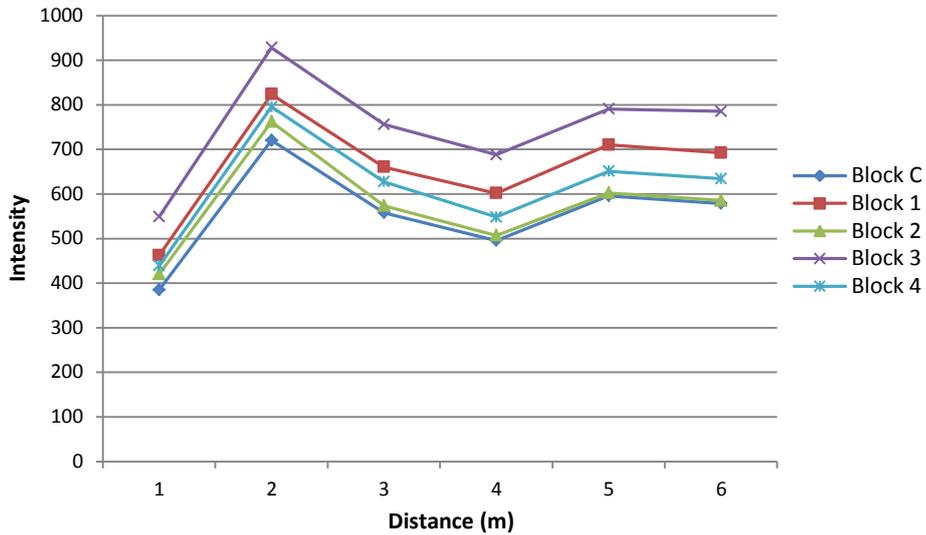
Fig. 11: Intensity against Distance at 0° Incidence Angle – HDS7000

In order to assess the effects of the distance on the intensity for the HDS7000 and FARO scanner data, the scanning incidence angle for the blocks was kept constant at  $0^\circ$  and only the distance was varied. The intensity-distance relationships for the concrete intensity data for all the blocks as scanned with the HDS7000 scanner are as shown in Fig. 11. The distance effects can be clearly observed for the uncorrected intensity as the expected theoretical trend where intensity return decreases with an increase in distance does not hold. The possible explanation for this is attributed to the instrumental effects of the scanner such as near distance reducers and logarithmic amplifiers which influence the laser measurements as documented in literature for various scanners [33].

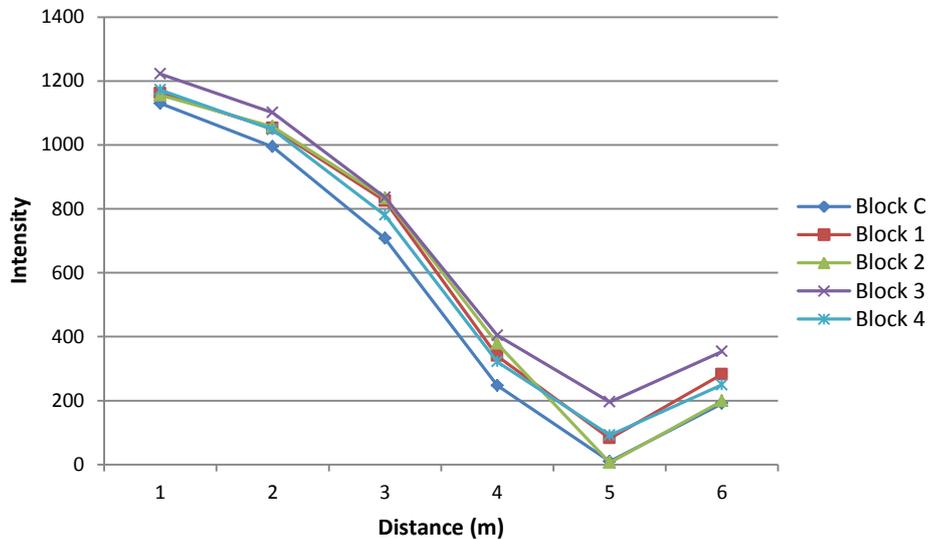
Fig. 12: Intensity against Distance at 0° Incidence Angle - FARO

The intensity-distance relationship for the FARO scanner data (Fig. 12) followed the theoretical trend of intensity decreasing with an increase in scanning distance. However, a slight amplification of the intensity was observed after 5m.

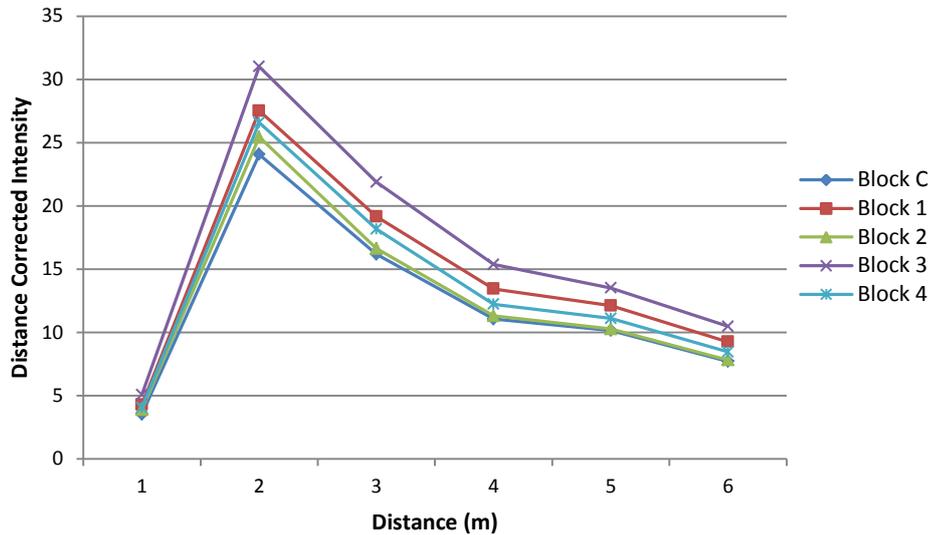
Fig. 13: Intensity against Distance at 0° Incidence Angle – HDS7000

The HDS7000 concrete intensity data was corrected for near distance effects by applying the correction method proposed in Fang *et al.* [31]. The intensity-distance relationship results after the correction was applied are as presented in Fig. 13 and it can be clearly seen that the correction is valid for distances greater than 1m as the rest of the scanning distances investigated follow the theoretical trend where a decreasing course for the intensity is observed over the whole range of scanning distances as the distance increases. Several researchers such as Kaasalainen *et al.* [27] have reported that scanning measurements taken at short ranges of 1m for instance have their intensities reduced in order to avoid overexposure of the scanner's photo-detector. In a similar vein Antilla *et al.* [18] used the HDS6000 scanner and reported that for the first 5m distances, the intensity is reduced so as to keep the level of the intensity within the realm of the sensor's dynamic range and from 5m and above, the intensity roughly follows the range squared inverse as described in the radar range equation.

The concrete intensity data from the FARO scanner showed insignificant near distance effects and no correction was applied. For both scanners used, the data analysed for incidence angles were below  $12^\circ$  and concrete was fairly smooth. Though the estimated parameters in Table 5 were obtained using the Z+F Imager 5006i laser scanner, the procedure and parameters were tested for the HDS7000 laser scanner since the two instruments are coaxial and basically the same in terms of their physical characteristics as designed by the manufacturer. The concrete intensity data acquired using the HDS7000 scanner could be corrected for all other distances with the exception of the 1m distance (see Fig. 13).

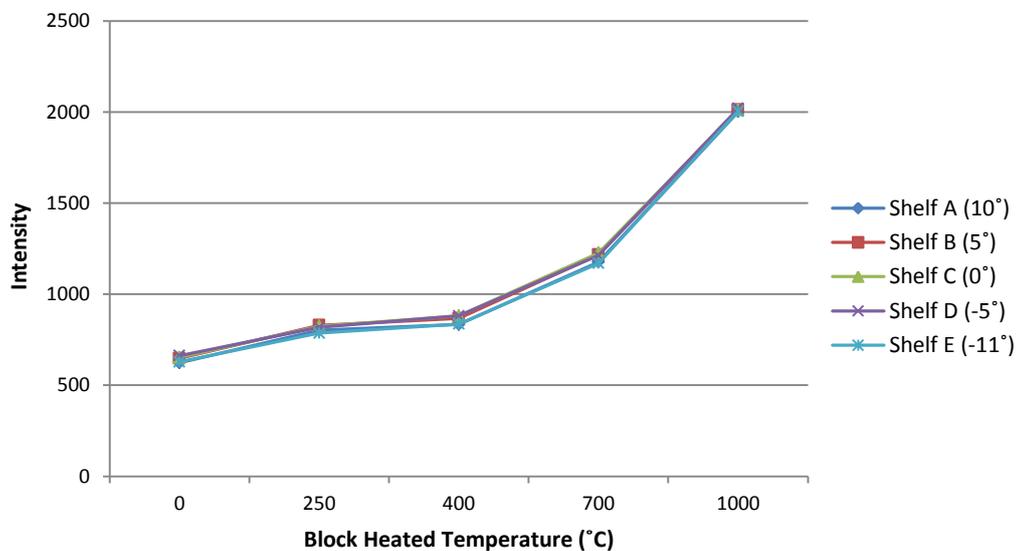
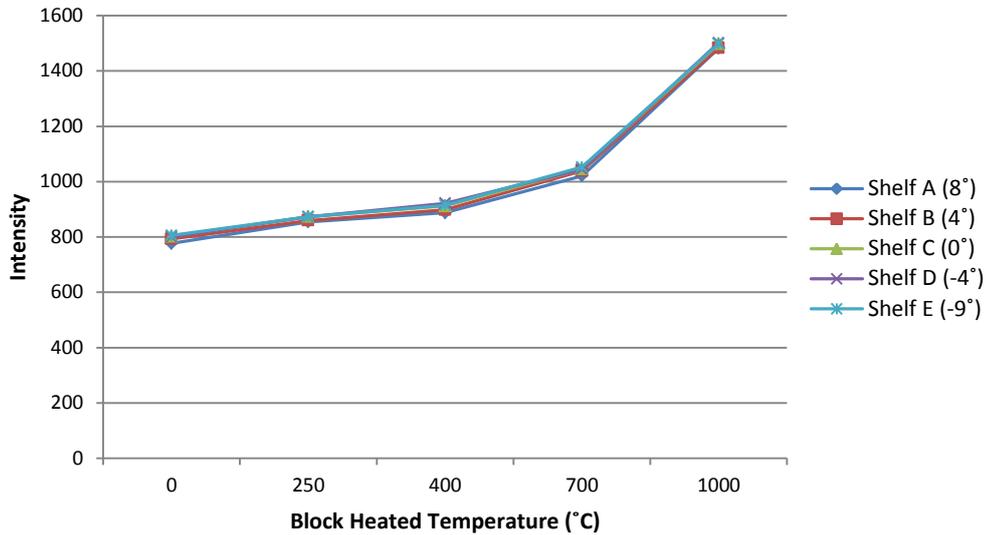
An analysis of the intensity recorded by the laser scanners for the heated blocks was carried out with the aim of studying the relationship between intensity and the temperature to which the blocks were heated. The data analysed and the results presented below are for blocks that were scanned at incidence angles less than 12° and with the scanning distance held fixed. Results of the relationship between intensity and the temperature to which the blocks were heated are as shown in Fig. 14 for the HDS7000 data and Fig. 15 for the FARO data. It can be observed that the intensity grows with the exposure temperature for the blocks. Several scanning distances were tested in an effort to find distances at which the relationship fits reasonably well and the result was such that the graphs (Fig. 14 and 15) converged to almost a straight line at a scanning distance of 5m for the HDS7000 scanner and 6m for the FARO scanner due to a reduction in the incidence angles (<12°) which was observed at these scanning distances. With reference to Fig. 14 and 15, the levels of fire-damaged concrete from the two scanners were assessed as shown in Table 6.

Fig. 14: Intensity against Block Heated Temperature at 5m – HDS7000

Fig. 15: Intensity against Block Heated Temperature at 6m – FARO

The relationship between intensity and the blocks which were heated to various temperatures was investigated by scanning the blocks at the respective distances and varying the incidence angles. The results of this relationship from both scanners showed that the intensity grows with the exposure temperature for the blocks. The results of the near distance corrected HDS7000 concrete intensity data also showed that the intensity grows with the exposure temperature for the blocks when the scanning incidence angle is fixed and the distances are varied. The achieved positive results relating intensity to exposure temperature of concrete demonstrate that laser scanning can be applied to assess levels of fire-damaged concrete and provide an understanding of the condition of concrete in relation to the strength changes of concrete when it is heated to elevated temperatures. It is worth stating that the influence of colour change of the heated concrete specimens on the intensity return did play a role to a certain extent as colour change is as a result of concrete composition and heating the concrete to elevated temperatures. Laser scanner intensity gave better results compared to intensity of RGB channels in terms of relating intensity to concrete exposure temperature. However, the results of RGB image analysis have shown that RGB can indeed be useful in roughly assessing the maximum temperature attained in fire-damaged concrete. From a colourimetry point of view laser scanners have an advantage as most of them have an external or internal camera which can be used to capture concrete images if good resolution can be achieved.

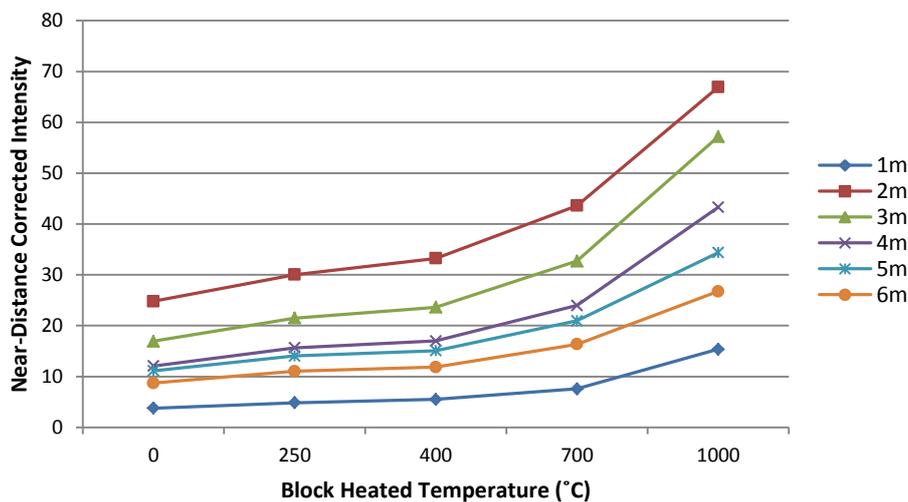
Fig. 16: Intensity against Block Heated Temperature at 0° Incidence Angle

After correcting the HDS7000 concrete intensity data for near distance effects, the relationship between intensity and the temperature to which the blocks were heated was investigated for blocks that were scanned constantly at 0° incidence angle and only varying the distances. The results of this relationship (Fig. 16) showed that the intensity grows with the exposure temperature for the blocks. The highest intensities were recorded at a distance of 2m and then a decreasing course for the intensities was observed over the whole range of scanning distances as the distance increased. Lowest intensities were recorded at a distance of 1m and this was attributed to be due to the instrumental effects which cause an intensity reduction at near distances to avoid sensor overexposure as mentioned above. However, even at 1m distance it can be seen that the intensity increases as the exposure temperature increases for all the blocks.

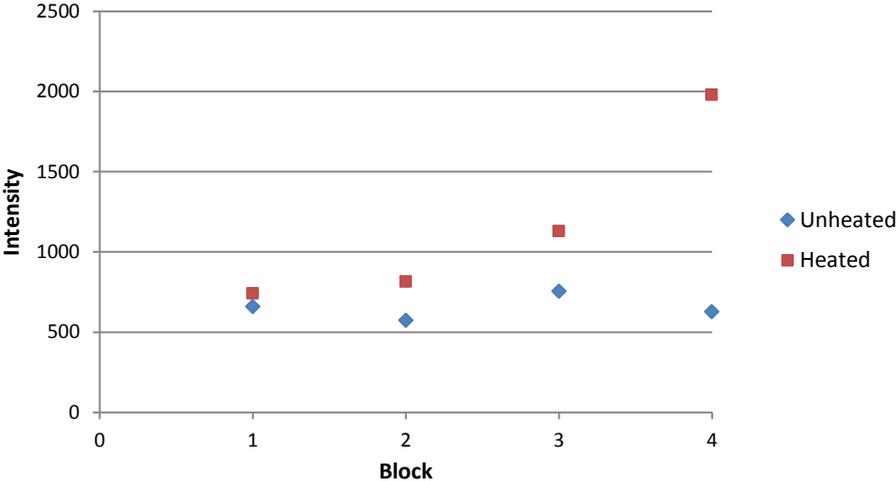
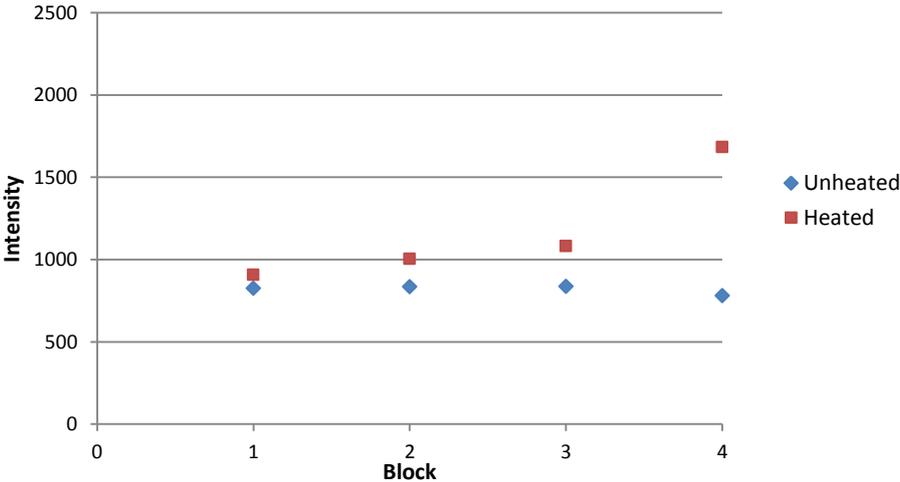
A comparison of the intensities of the concrete blocks before and after heating was investigated aimed at assessing if there were any differences and recognisable patterns rather trends that could be drawn in relation to exposure temperature that each block was heated to. The results of the comparison are shown in Fig. 17 for the HDS7000 scanner data and in Fig. 18 for the FARO scanner data. The results presented are for scans that were taken at a scanning distance of 3m and at various incidence angles. It can clearly be seen from both Fig. 17 and 18 that the intensity values of the blocks increase after heating. Furthermore, an upward trajectory trend can be seen where the intensities of the blocks increase in relation to the increase in exposure temperatures of the blocks i.e. block 1 (250°C), block 2 (400°C), block 3 (700°C) and block 4 (1000°C). The observations held true for all the incidence angles and other scanning distances investigated though an optimised scanning geometry produced better results.

Fig. 17: Comparison of Unheated and Heated Concrete at 0° Incidence Angle - HDS7000

Fig. 18: Comparison of Unheated and Heated Concrete at 0° Incidence Angle – FARO

A comparison of heated and unheated concrete based on the laser scanner intensity to assess if there was a difference between heated and unheated concrete proved successful. Results from the two scanners clearly showed that there is a remarkable difference in the intensity values of heated and unheated concrete and it was observed that the intensity values increased with an increase in exposure temperature. The results of this comparative analysis are valuable in that they have shown that it is possible to use laser scanning to identify differences in the state of concrete before and after heating as a change detection technique.
