A Novel Method to Produce Kiss-bonds in Composites Components for NDI and Characterisation Purposes

Abstract

A novel method for manufacturing composite material test panels with kiss-bond defects (for research or NDI calibration, for example) in a controlled and repeatable fashion has been developed. Small areas of two adjacent pre-preg plies were pre-cured before being incorporated within a laminate. During consolidation, no bonding occurs between the pre-cured areas, thus creating a kiss-bond defect of known geometry. Test panels with 6x6 mm and 10x10 mm kiss-bond defects were manufactured. The robustness of the technique was verified using ultrasonic and laser shearography NDI methods; 7 of the 10 manufactured defects were classified as kiss-bonds, with the remaining 3 identified as dis-bonds.

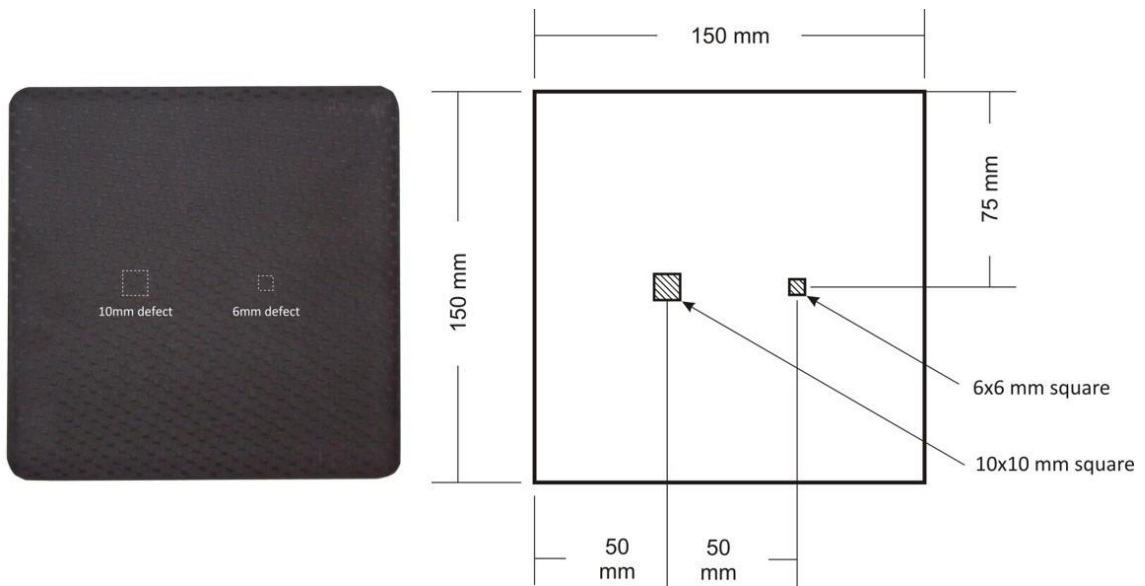
Figure 2 - Dimensions of the panels produced, showing the kiss-bond area locations

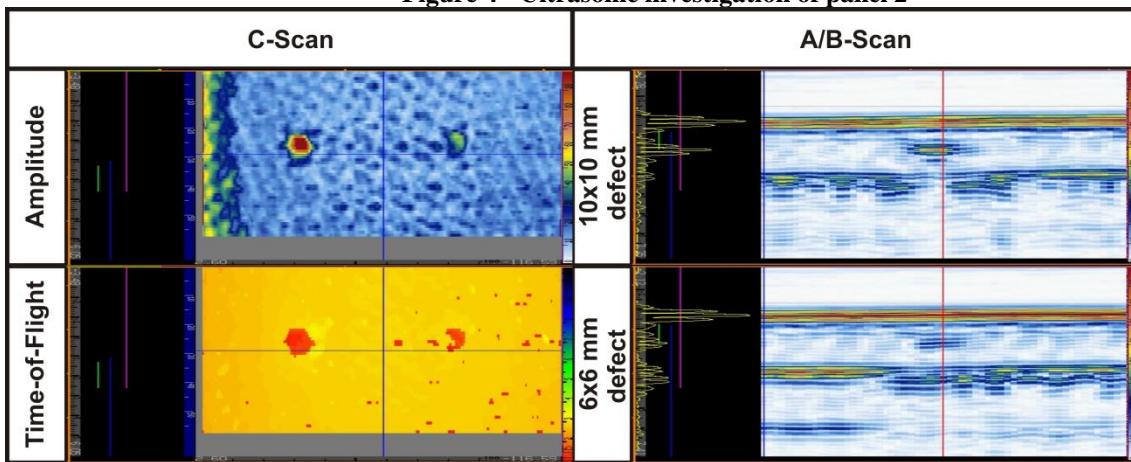
Figure 5 - Ultrasonic investigation of panel 3

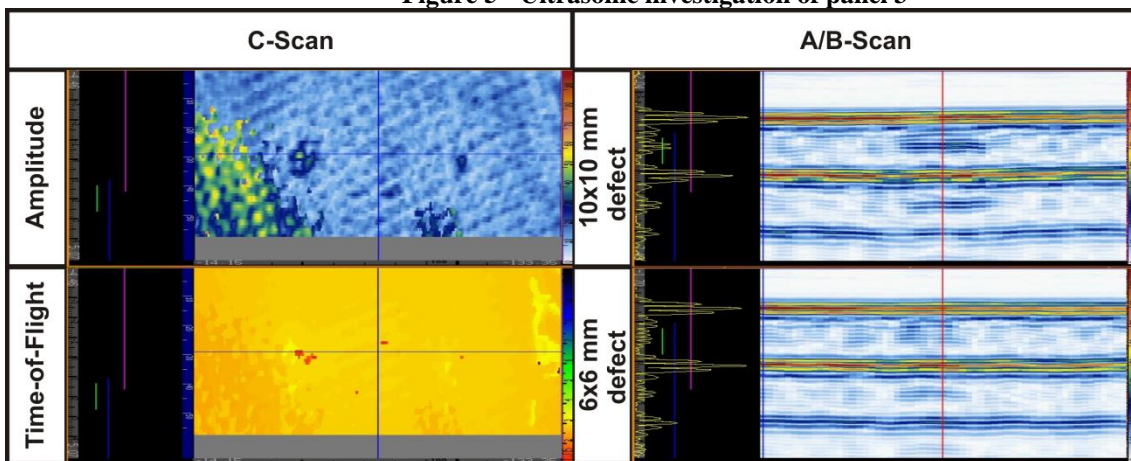
Figure 6 - Ultrasonic investigation of panel 4

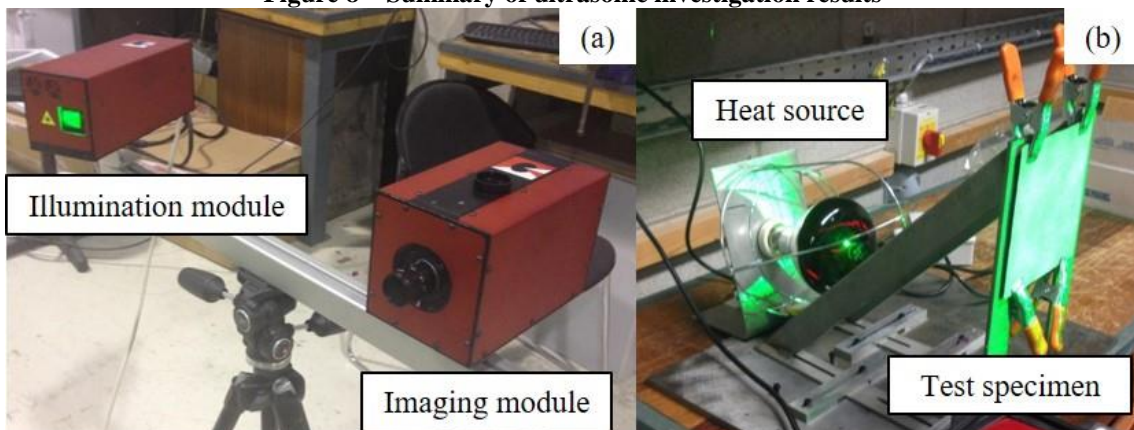
Figure 9 - (a) Laser shearography NDI system and (b) test specimen and clamp used

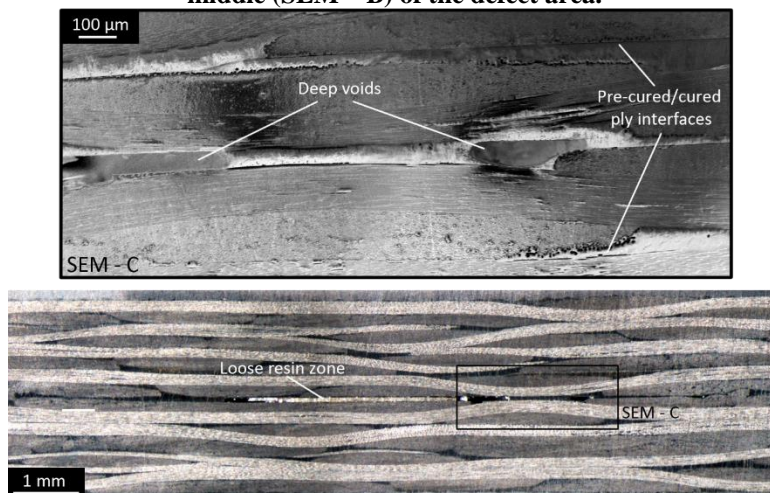
Figure 12 Cross-section of the 10 x 10 mm defect specimen, with feature close-up (SEM – C).

Optical microscopy showed that the middle pre-cured plies in each defect specimen were quite flat, with a 50-100 μm thick resin-rich region between them, as seen in Figure 11 and Figure 12. However, despite careful layup, the two adjacent pre-cured areas were not perfectly aligned; reflected by a slight offset between these flat regions at the defect edges.

Alternatively, the 10 x 10 mm defect revealed large and deep voids, as seen in Figure 12, which encased a significant amount of 'loose resin' that did not appear to be bonded to the pre-cured plies on either side of the interface. This loose

At high magnification, there were also signs of the interfaces between the pre-cured plies and the rest of the cured laminate, shown in SEM - C from Figure 12. However, these did not extend for the full length of the 10 mm defect.
